## High human influence on beach response to tropical cyclones in small islands: Saint-Martin Island, Lesser Antilles

Virginie Duvat, Valentin Pillet, Natacha Volto, Yann Krien, Raphaël Cécé,  
Didier Bernard

Virginie Duvat, Valentin Pillet, Natacha Volto, Yann Krien, Raphaël Cécé, et al.. High human influence on beach response to tropical cyclones in small islands: Saint-Martin Island, Lesser Antilles. *Geomorphology*, 2019, 325, pp.70-91. 10.1016/j.geomorph.2018.09.029 . hal-01924514

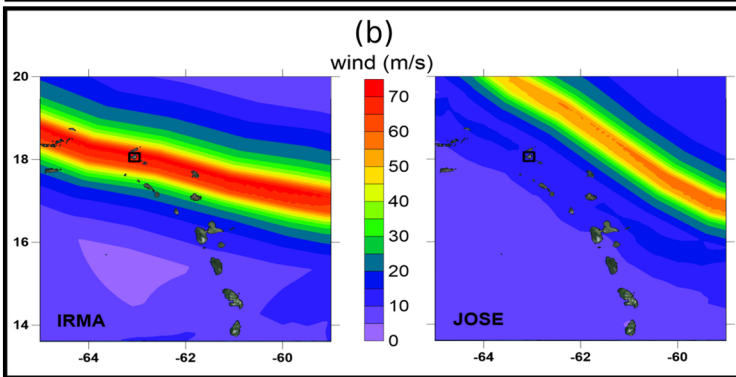
Figure 3

During the 2017 North-Atlantic cyclonic season, 17 storms, 10 hurricanes and 6 major hurricanes were observed. This season was characterized for the Lesser Antilles by three extreme hurricanes, Irma, José and Maria, associated with extreme sustainable wind speed values reaching or exceeding 250 km/h (Figs. 3a-c). The main features of these hurricanes are summarized in Table 2.

Three days after Irma, category 4 tropical cyclone José passed to the north at some 130 km from Saint-Bartholomew and Saint-Martin (Fig. 3a), without causing significant damage. The maximum significant wave heights still reached about 5 m off the eastern coast of Saint-Martin, according to the numerical results obtained with SCHISM-WWM (Fig. 3d-right), but the

Category 5 TC Irma was born west of the Cape Verde islands (Degrace, 2017). Upon its arrival on the Lesser Antilles Arc on 6 September 2017, sustainable wind speed values were close to 296 km/h and wind gusts were estimated at 361 km/h. These extreme eyewall winds devastated the island of Barbuda before hitting Saint-Bartholomew, Saint-Martin and Anguilla on the early morning of 6 September. Irma was the first recorded TC crossing the Lesser Antilles islands with such powerful winds. Due to the heavy induced damages, very limited meteorological observational data could be collected in Saint-Martin and Saint-Bartholomew during this event. To compensate for the lack of in-situ data, and to have spatial-temporal meteorological fields to understand the impacts, an atmospheric simulation was effected with the WRF ARW model

(Skamarock et al., 2008) and a 0.4 km-resolution domain to take into account the complex shorelines of a 15 km-wide island like Saint-Martin (Cécé et al., 2014). The 6-hourly ECMWF operational analyses with  $0.1^\circ$  scale were used as initial and boundary conditions. The results (Fig. 3c) show maximum surface winds on the Atlantic side of Saint-Martin with huge gusts of 341 km/h. The maximum simulated wind speed on the coast of Saint-Martin reached 305 km/h. Based on the simulation results, the coastal areas affected by the strongest winds (above 280 km/h) were Nettle Bay, Grandes Cayes, Oyster Pond and the Terres Basses coasts from Baie Aux Cayes to Baie aux Prunes.

As there are no meteorological buoys in the area of Saint-Martin, no direct wave observation is available. Using bathymetric data from navigational charts provided by the SHOM (French Navy Hydrographic and Oceanographic Service), as well as wind fields obtained by blending CFSR data with empirical laws, we estimated that the significant wave heights ( $H_s$ ) exceeded 5 m off the coasts of Saint-Martin (Fig. 3d). The eastern coast was the most exposed, with  $H_s$  reaching 9 m. Our results suggest that the northern and southern coasts were also impacted, but with significant differences depending on the location. West-facing coasts were presumably much less exposed, since the winds were offshore during the peak of the storm. A description of SCHISM-WWM, the wave-current coupled numerical model used here, can be found in Krien et al. (2017). The tide gauge of Marigot city on the northern coast recorded a surge of 2 m. This value is consistent with the results of our storm surge numerical model, which also indicates that the water level might have reached 5 m above mean sea level locally on the eastern coast, for example in Embouchure Bay.

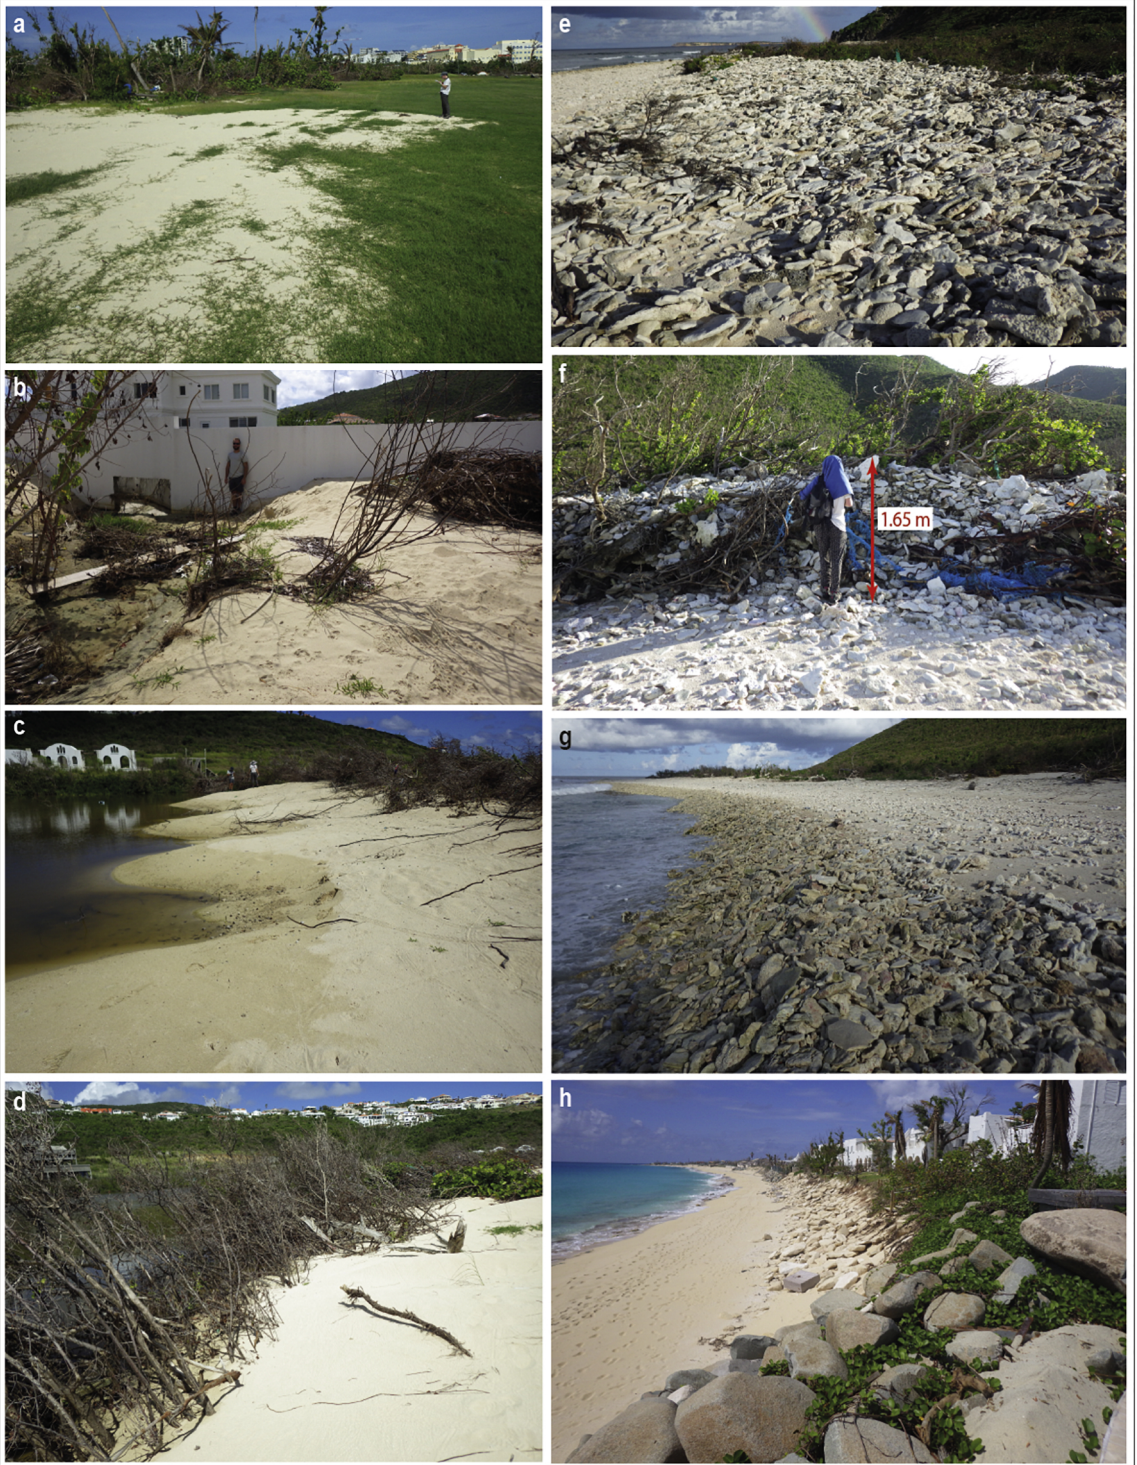
Figure 9

While erosion predominated on beaches and upper beaches, sand accumulation prevailed in inner land areas as a result of overwash where no obstacle, neither natural (i.e. dense vegetation) nor human-built (i.e. buildings and engineered structures), obstructed sediment transport pathways. Extensive sand sheets indicating massive sediment transfer from beaches to

inner land areas were the most common feature observed (Fig. 9, SM3). In open areas, sand deposits penetrated inland over great distances, i.e. 135 m, 105 m and 75 m from the pre-cyclone vegetation line at Simpson Bay, Nettle Bay (west) and Mullet Bay, respectively (Fig. 9a). At most sites, the maximum thickness of these sand sheets ranged from 0.10 to 0.80 m (Fig. 9b). It reached the maximum value of 2 m on the highly-exposed eastern coast at Gibb's Bay (Fig. 9d). Moreover, at two sites (i.e. Red Bay and Gibb's Bay), barrier beach overwashing by the cyclonic waves caused sediment deposition in the inner lagoon, where sand lobes formed (Fig. 9c). In addition, at one site (i.e. Embouchure Bay), a new channel (maximum dimensions of 15 m x 75 m) formed across the barrier beach. Of note, on the north-eastern back-reef beaches (namely Petites Cayes Bay and Petites Cayes Beach), the substantial transfer to the coast of coral debris (primarily shingle and rubble, and secondarily blocks) led to the formation of crescent-shaped deposits at the base of the beach (Fig. 9g) and of a 0.80 m-high, 20 m-wide and 60 m-long beach ridge on the upper beach (Fig. 9e). Additionally, on highly eroded beaches bordered with beachrock slabs, the dismantling and landward transfer of fragments of the latter caused block accumulation at the beach surface and along the erosion scarps cut by cyclonic waves in upper beaches and sand dunes (Fig. 9h).

a Cyclone-generated 2 to 8 cm-thick sand sheets extending over a maximum distance of 75 m from the pre-cyclone vegetation line, central part of Mullet Bay. b 0.80 m-thick sand deposits recorded in open areas between buildings at Guana Bay. c and d Gibb's Bay. c Sediment deposition resulting from wave overwashing of the 40-50 m-wide barrier beach. Sand lobes formed along the entire lagoon-side shoreline. d Sand deposition against the natural vegetation in the inner part of the barrier beach. e, f and g show accretional features observed on Petites Cayes Beach. e The beach ridge that formed at the top of the shrubby vegetation, as a result of the transfer of coral debris and blocks from the fringing reef to the beach. f Major role of the dense coastal vegetation in trapping coral debris and blocks. g Crescent-shaped shingle deposit structure that formed at the base of the beach. h Beachrock fragments' accumulation against cyclone-generated erosion scarps cut in Longue Bay sand dunes. These deposits result from the dismantling of exhumed beachrock slabs that can be seen in the wave breaking zone on the same photograph.
